Consideration of Total Station as Baseline for Tape Measurements Improvement in Holing Prediction at Underground Deep Level Gold Mine

Abstract—Over the last few years, accurate and safe break-through (holing) has been a problem in Underground deep level gold mines because of factors including the inherent inaccuracy of tape measurements.

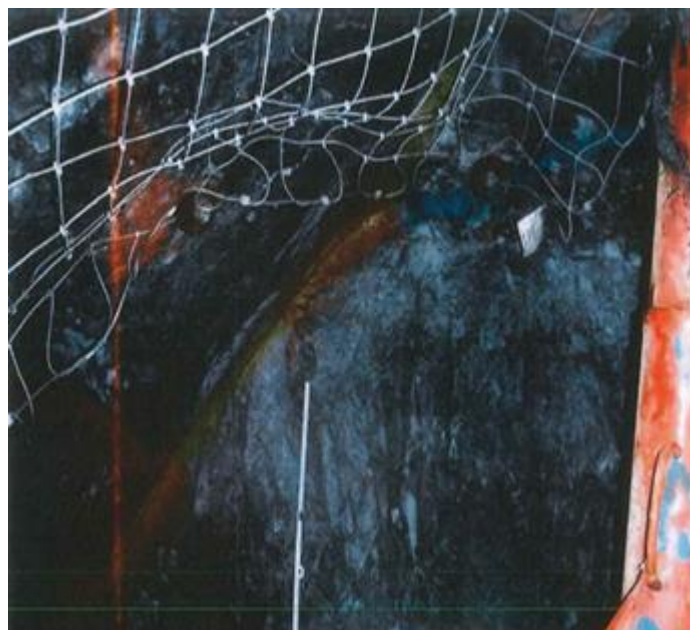
Fig. 2 underground stope face

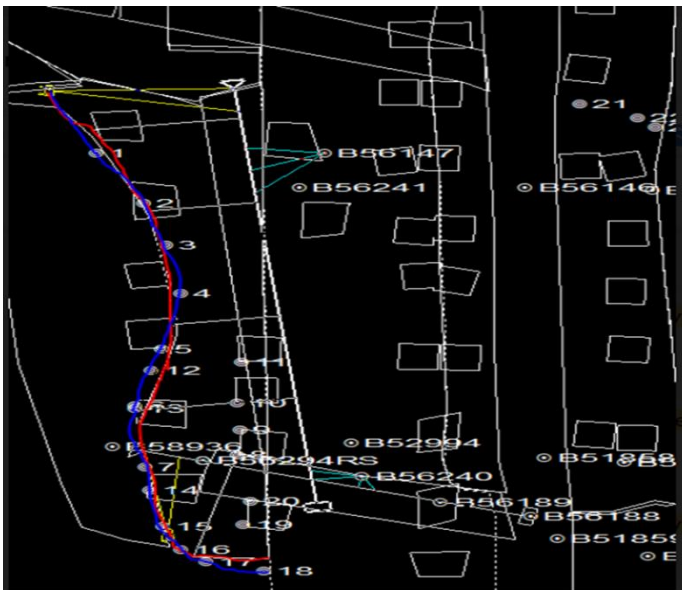
Fig. 7 KL33 16 08S showing underground face that was measured by tapes and also measured by Total station.

From the results, it can be concluded that the tape measurements are less accurate compared with Total station measurements. The Figure 3 above showing the blue line of tape measurements indicates that those measurements are not in the position where the face is supposed to be, and the red

line which is total station measurement I goes along exactly to the face position.
